# Study and Characterization of Seawater Reverse Osmosis Fouled Membranes from Large Scale Commercial Desalination Plant

Study and characterization of Seawater Reverse Osmosis Fouled Membranes from Large Scale Commercial Desalination Plant

The fouled RO membrane element (HYDRANAUTICS SWC 5) serial number: A1497030 selected for the autopsy study had been in service for nearly 2 years in a water treatment facility operated by Benisaf Water Company of Ain Temouchent in the Ouest of Algeria. The RO desalination plant was integrated into the water treatment facility in response to the increased salinity of sea water in the region. The Fouled membrane as inspected with;

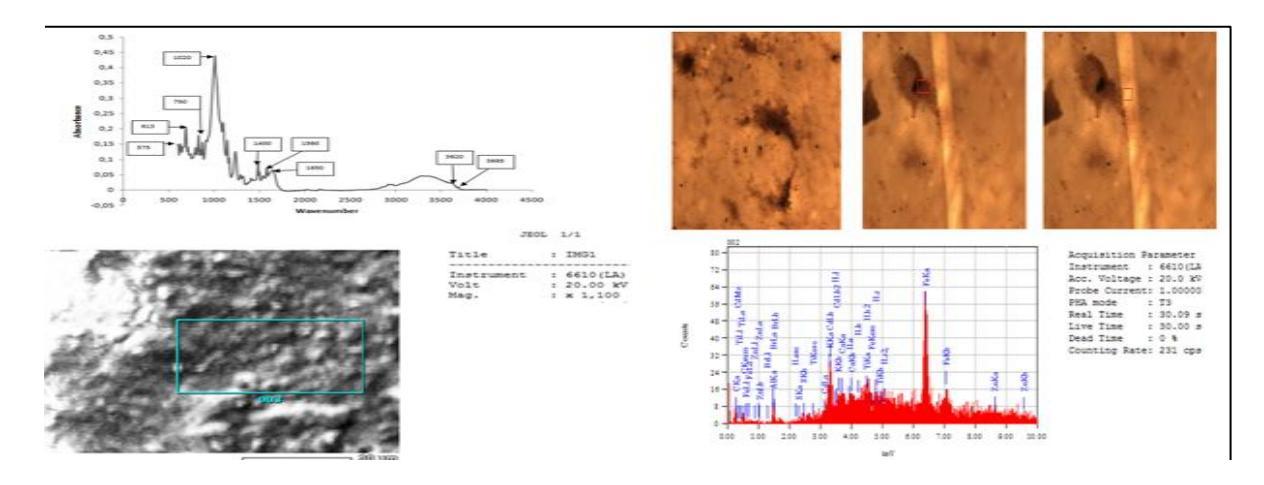
Figure 1. SEM image, micrograph and Chemical composition of the membrane surface.

Microscopic observation of samples reveals the importance of fouling deposition in the membrane surface. The SEM images show the morphological aspect of the fouling as well as the importance of the thickness of the layers as shown in Figure 1.

Inspection by SEM EDS confirms the diversity of the fouling composition layer across the surface of the membrane [2], and The main absorption bands were in the vicinity of 1020 cm-1 (Si-O and Al-O) of silicate [1].
